RI 9280

## Leakage Across a Bituminous Coal Mine Barrier

By Noel N. Moebs and Gary P. Sames

BUREAU OF MINES

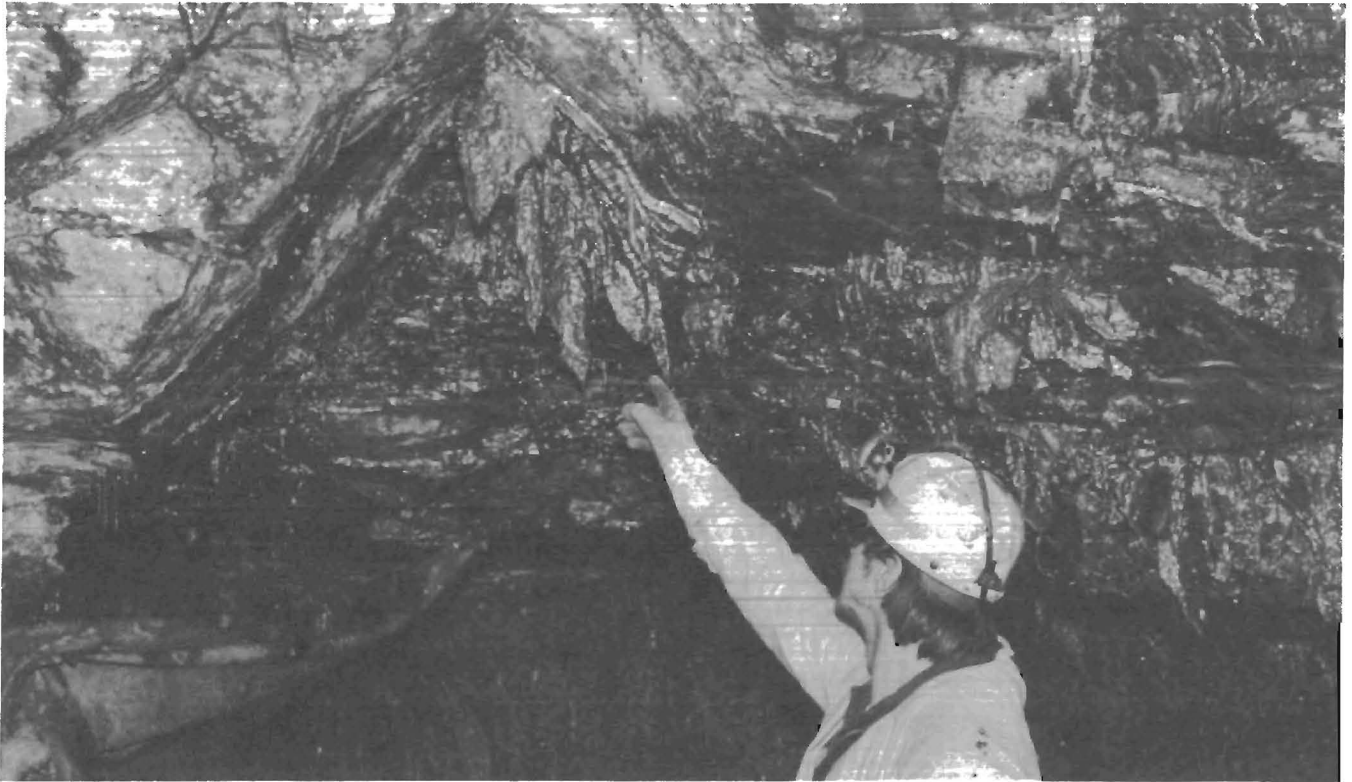
Visual examination of roof falls near the point of major water inflow revealed a pronounced change from the normal hard shale roof throughout most of the mine to a locally soft deformed claystone with some lenses of hard sandstone. The identity and trend of the geologic structure in the roof could not be determined easily because of the ragged and iron-stained condition of the roof (fig. 8). Some discernable fracture trends are shown on figure 9.

Figure 8.—Ragged character of mine roof and deposits of yellow boy.

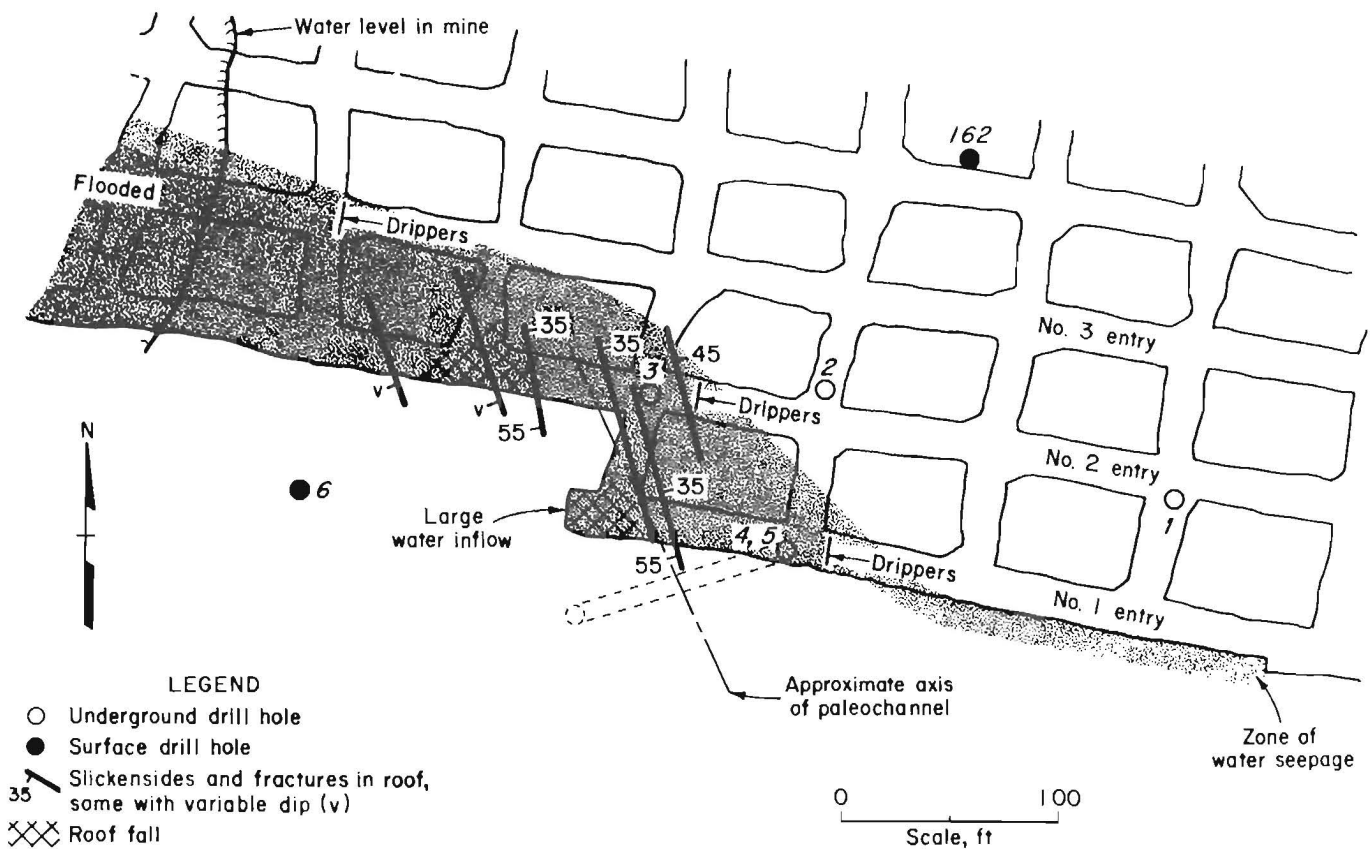
Figure 9.—Fracture trends in zone of large water inflow.

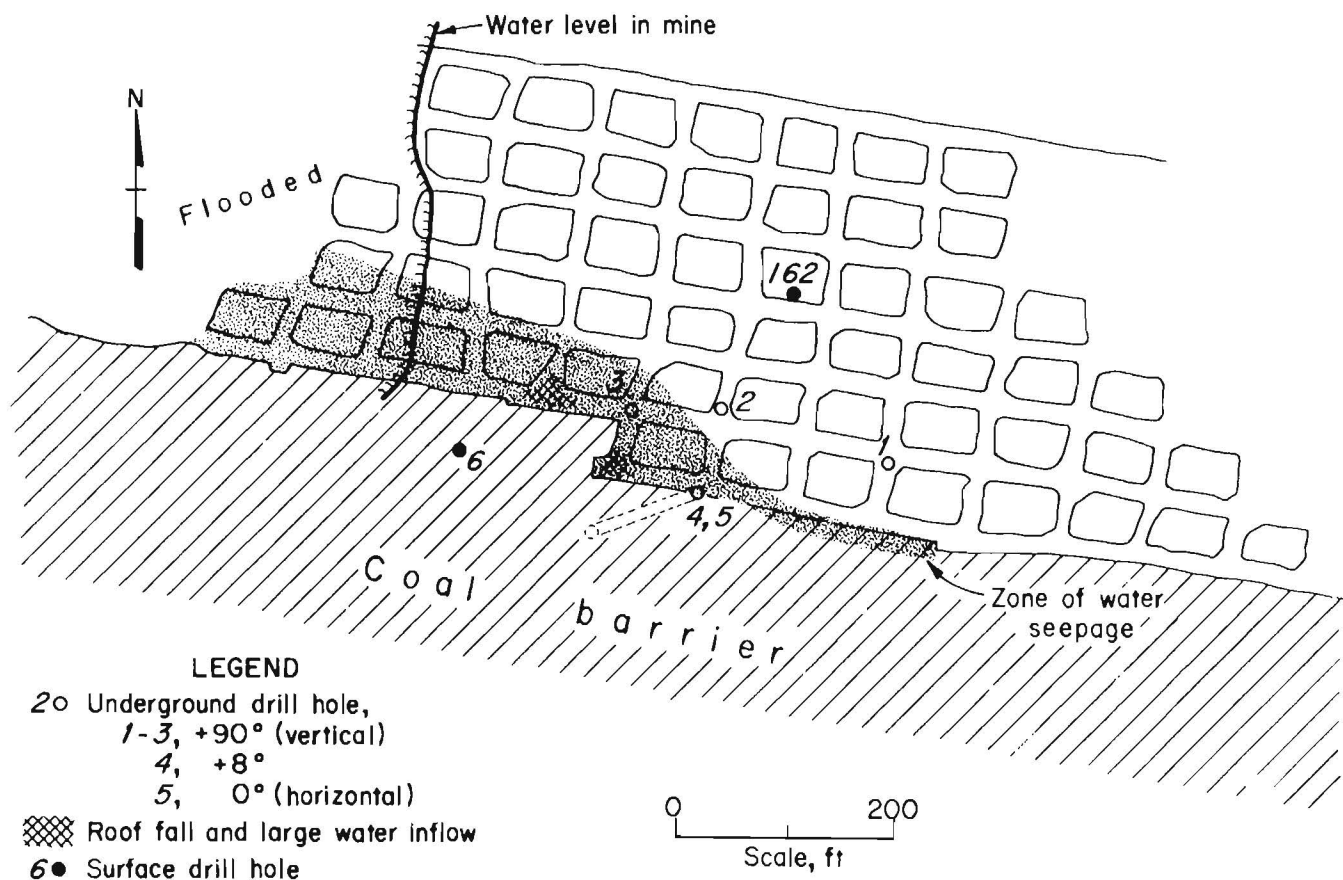
Figure 11.—Location of drill holes and zone of water seepage.

Hole 5, drilled horizontally into the coal barrier (fig. 11) to a depth of 50 ft produced only 0.75 gpm on completion. This, along with the very gradual seepage of mine water from the solid coal rib into which the hole was drilled, strongly indicates that the coalbed is a poor aquifer and not the pathway for the large quantities of water flowing from the mine roof.

Hole 6 was drilled from the surface to the base of the coalbed at a depth of 208 ft. It was located 125 ft ahead of the No. 1 entry (fig. 11) to help define the margin of the sandstone channel inferred from the logs of holes 1 through 5, and provide for sampling ground water. The water level in the hole stabilized at 88 ft below the surface or 108 ft above the coalbed.

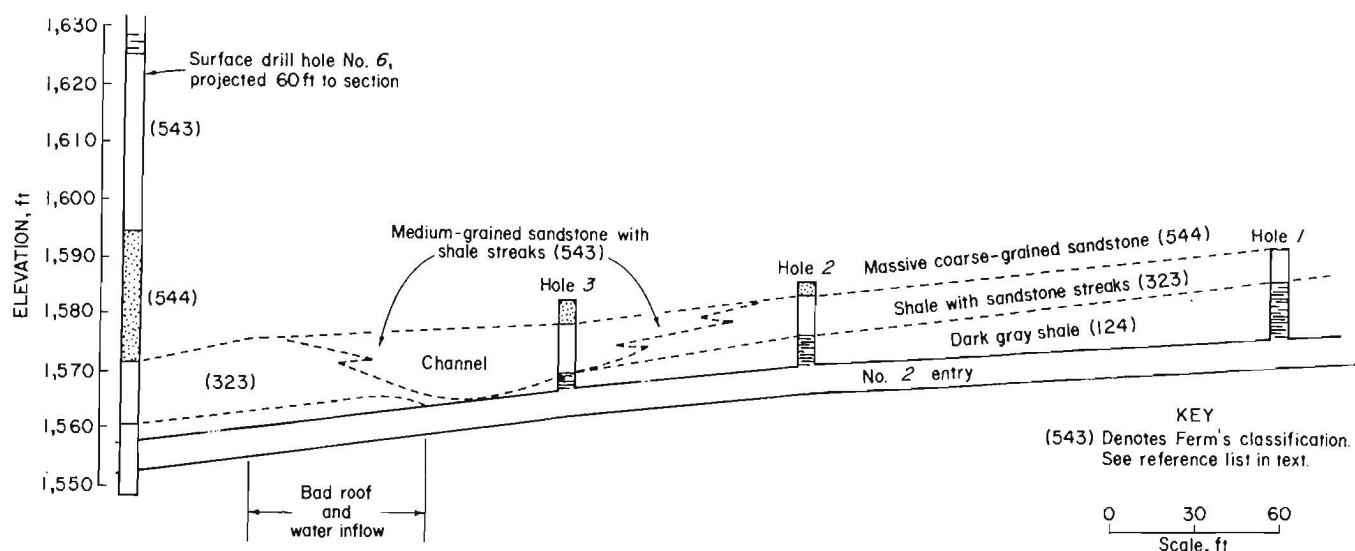
The base of the sandstone channel at hole 3 lies about 3 ft above the mine roof and has little effect on the roof stability, although about 50 ft west of hole 3 near the margin of the channel the roof conditions are poor, supplementary support is required, and roof drippers are profuse. This difference could be attributed to the effects of differential compaction, with the formation of distorted bedding, slumping, and slickensides, commonly associated with the margins of sandstone-filled channels.

Virtually no water inflow was intercepted in either holes 1, 2, or 3. This indicates that the local water pathways lie at least 50 ft westward where the roof drippers occur. It also indicates that the sandstone channel-fill itself does not constitute an aquifer or significant pathway for the water impounded in the adjacent mine. Roof and water conditions precluded the drilling of a test hole west of hole 3 where some marginal effects of the channel, such as slumping and slickenside concentrations and enhanced permeability, might have been detected.

Figure 12.—Profile of mine roof showing structure and lithology based on core drilling.

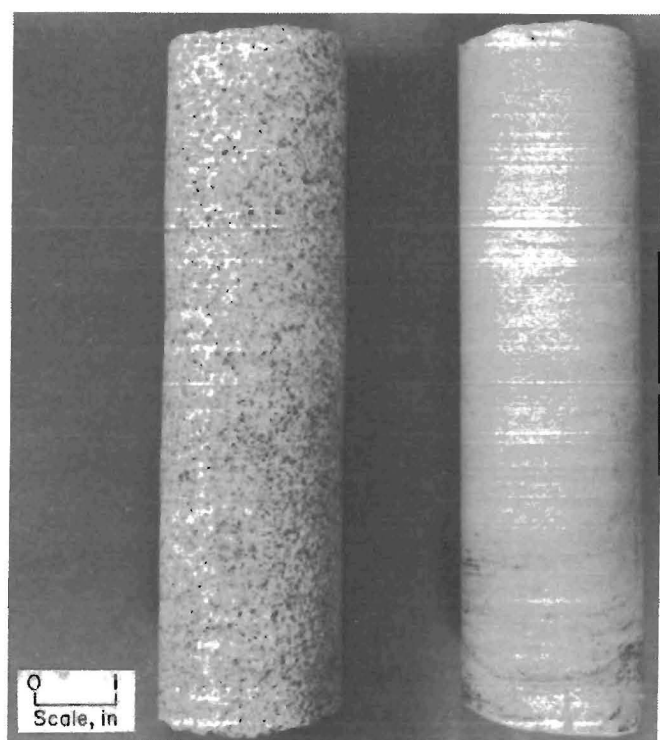
Figure 13.—Medium-grained channel-fill sandstone (right) and overlying coarse-grained Mahoning Sandstone (left).

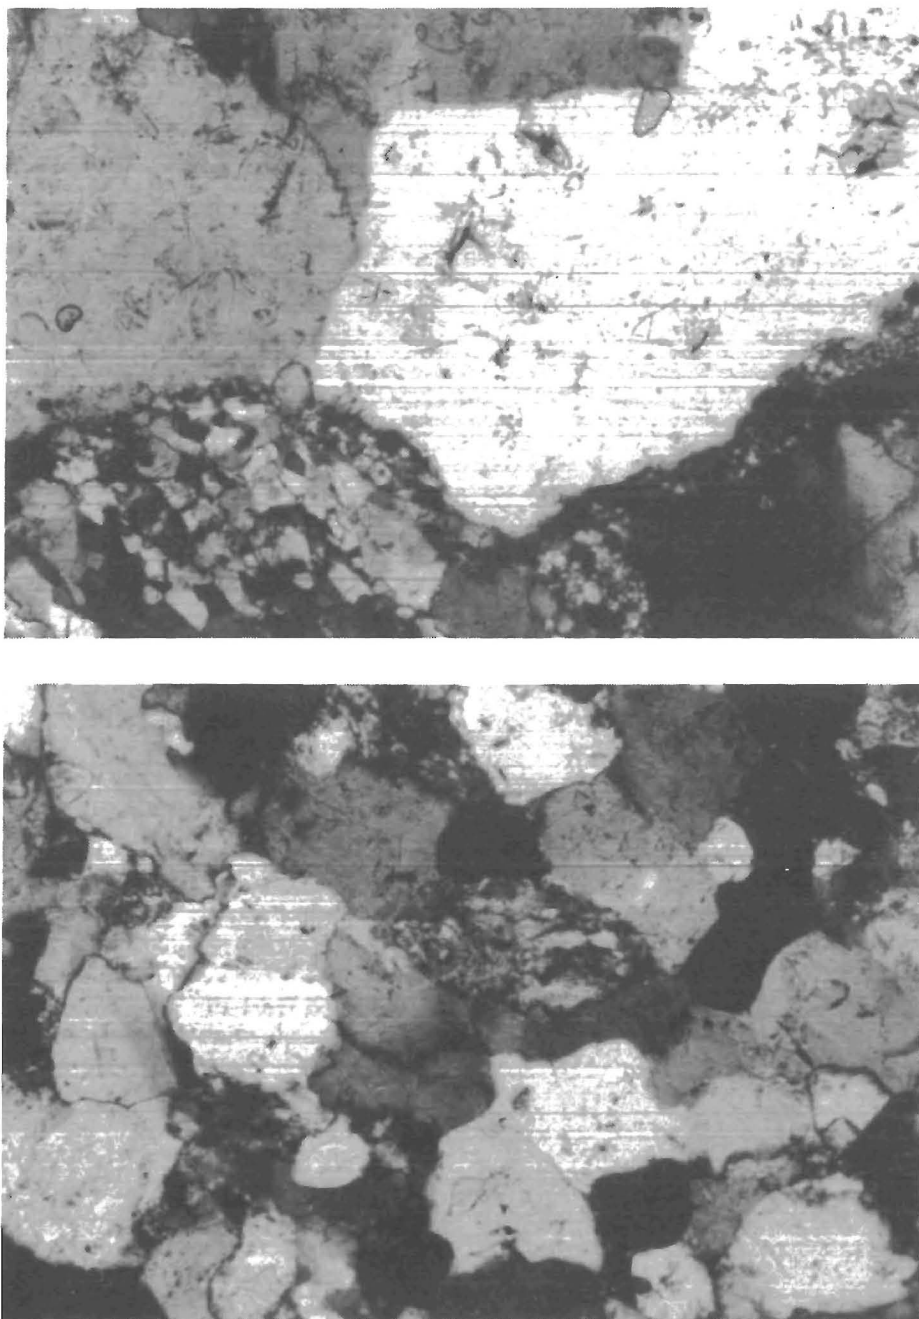
Figure 14.—Texture of channel-fill sandstone (bottom) and overlying Mahoning Sandstone (top) ( $\times 100$ ).

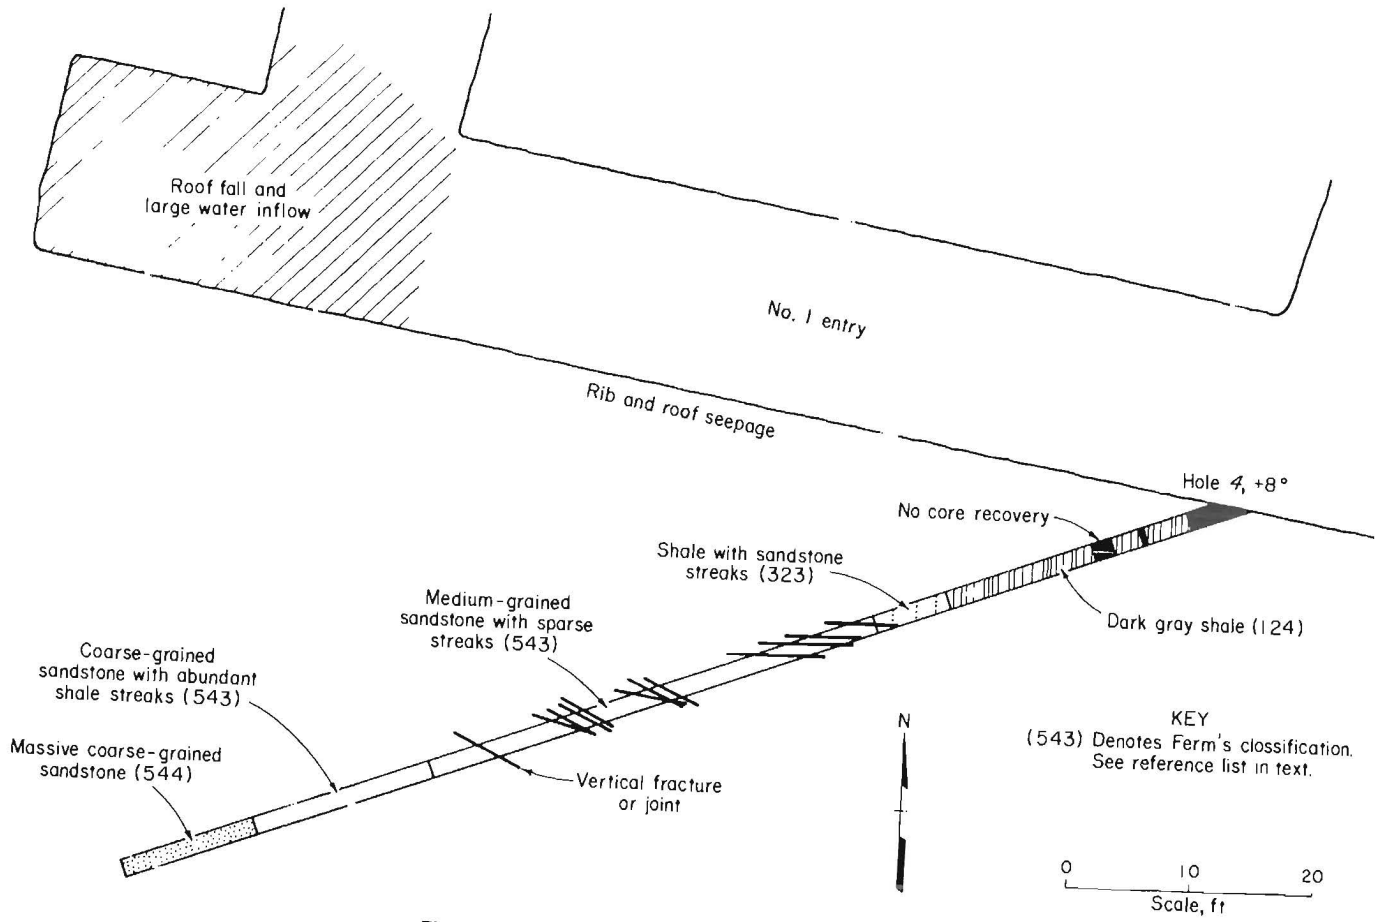
Figures 15 and 16 summarize the results of drilling hole 4. This hole was drilled to probe a northwest-trending

Figure 15.—Plan view of drill hole 4 and No. 1 entry.

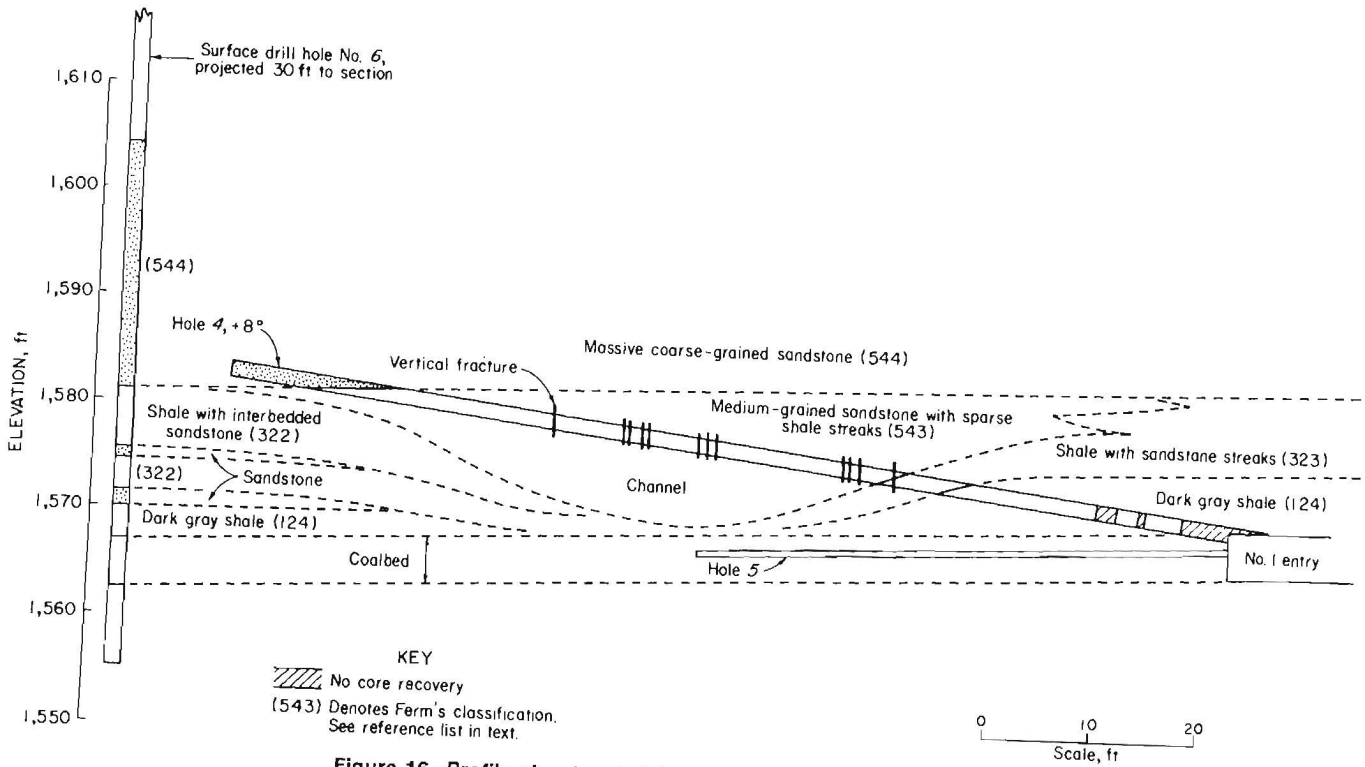
Figure 16.—Profile showing drill hole 4 and structure of roof rocks.
